Testing and developing of desludging units for emptying pit latrines and septic tanks

Results of nine months field-testing in Blantyre - Malawi

Emergency Sanitation Project

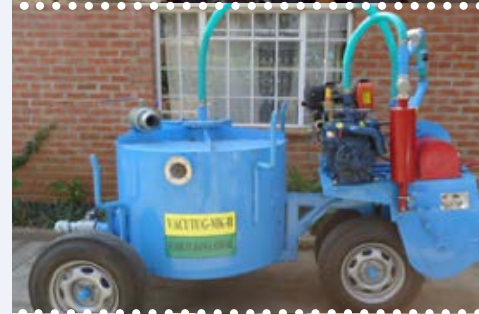
Fig 1: ROM 2.

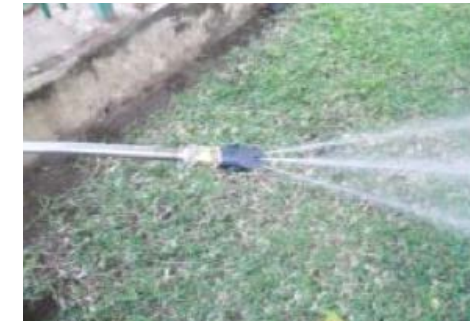
Figure 1: Spray pattern using a 4 jet nozzle at 100 bar.

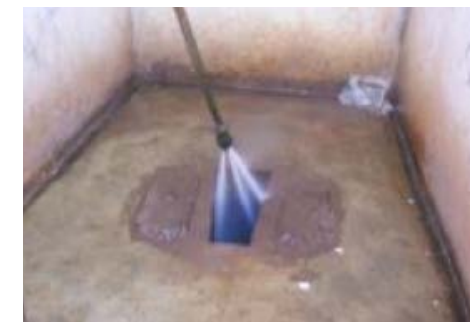
Figure 2: The water jet is also essential for cleaning the toilet slab and the desludging equipment.

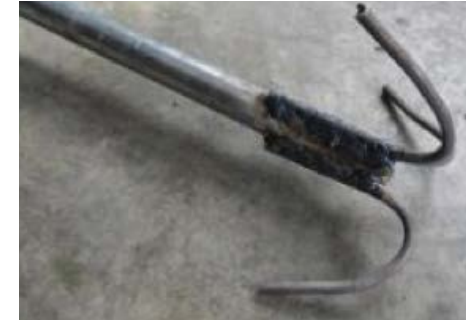
Figure 3: Fishing tool.

Fishing of rubbish is one of the most important steps to ensure efficient removal of sludge from a pit latrine or septic tank. It is also the most unpleasant and hazardous part of the operation, but until different pump technologies are developed, or households refrain from disposing of garbage in pits, it will remain a necessary operation. The amount and type of rubbish found in a pit must be seen to be believed. Out of 54 pits we fished 2840 litres of rubbish, which averages about 50 litres per pit (see Annex C). Fishing is time consuming, taking on average 30 minutes per pit, sometimes more. The fishing tool is a 1.6 m to 1.8 m, 12mm GI pipe with 3 x 6mm grapples welded to it. See Figure 3.

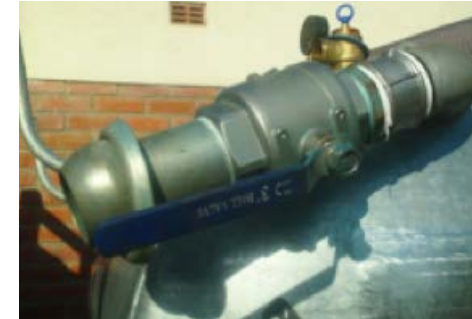
Figure 6: The ball valves should be of best quality to ensure efficiency of the machine and long service life.

The equipment has 2 x 3” ball valves – 1 at vacuum side of the tank and 1 at the discharge side of the tank. In order for the tank to reach adequate vacuum (0.5 bar) or pressure (1.0 bar) it is essential that both valves are completely leak proof.

- They wear out due to abrasive action of the sand and grit.
- They become extremely hard to open or close.
- They lose their seal making desludging inefficient.

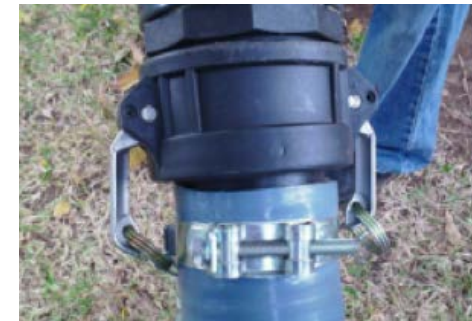
Figure 7: The coupling should be firmly anchored to the suction pipe using a high torque clamp band. Definitely don't use “jubilee clips”!

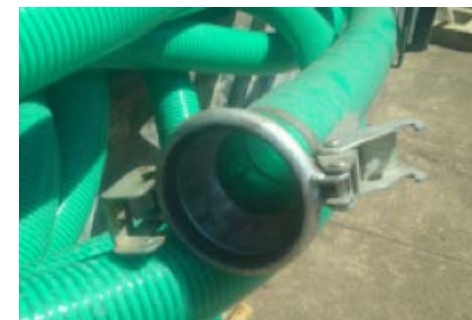
Figure 8: Camlock couplings should be of best quality in order to ensure efficiency of the machine and long service life.

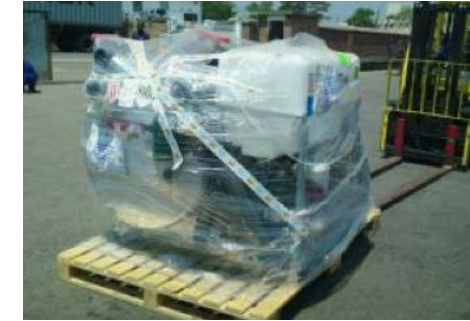
Figure 11: The ROM2 was shipped on a standard pallet.

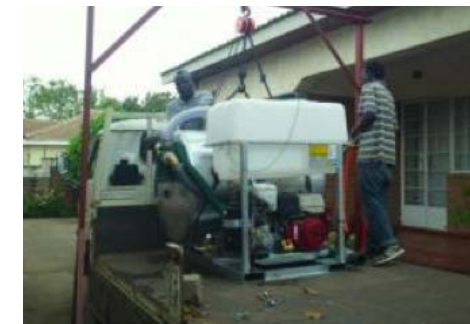
Figure 12: The ROM2 was easily deployed but required lifting gear.

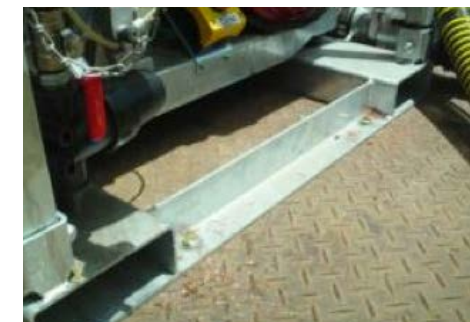
Figure 13: The ROM rig should be firmly bolted on its transport.

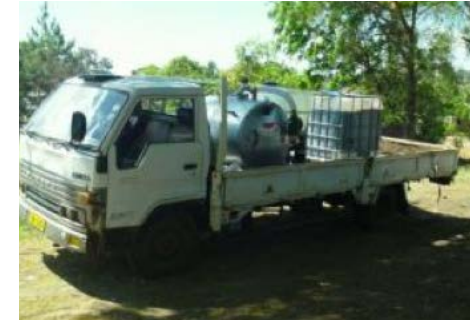
Figure 14: The 3 ton truck carrying 700 l 800 litres sludge in the ROM and 1000 litres sludge in the IBC for disposal at the Blantyre Sewage treatment plant. No spillages en route.

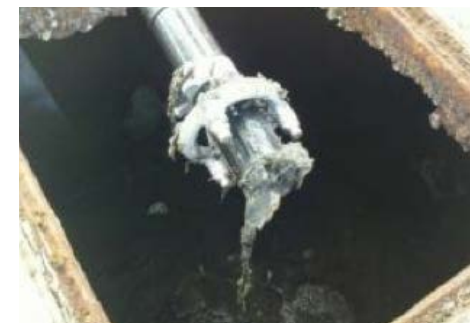
Figure 15: The 2" kit was blocked even with septic tank sludge as menstrual management materials are often flushed down the toilets.

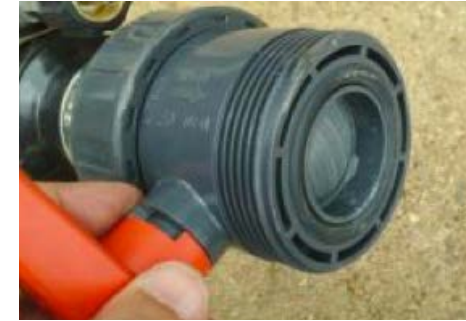
Figure 16: The plastic ball valve showed signs of abrasion after only a few operations and the threads were easily crossed by operators.

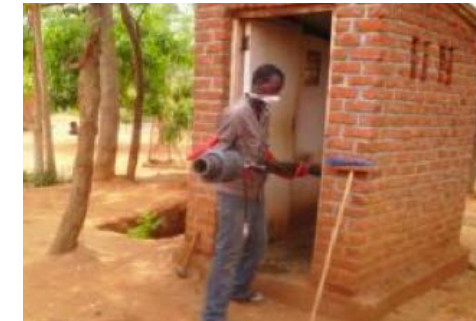
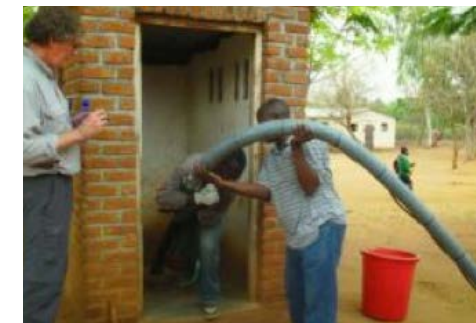
Figure 19: Cumbersome lance.

Figure 20: Cumbersome lance.

One of the main challenges we faced was the setup of the suction pipe that came with the ROM2. Table 4 provides a list of the issues, with the recommended solutions. One of the main problems was the operation of the lance. The lance is too heavy and too cumbersome the use. There are too many operations: apart from ROM2 operating the emptying the operator has to control the valve for the pressure washer and the valve for the suction pipe. We removed the valve and the fluidiser at the suction side. For smaller toilets the lance has to be assembled in the toilet otherwise it cannot enter the drop hole. See Figures 19 and 20.

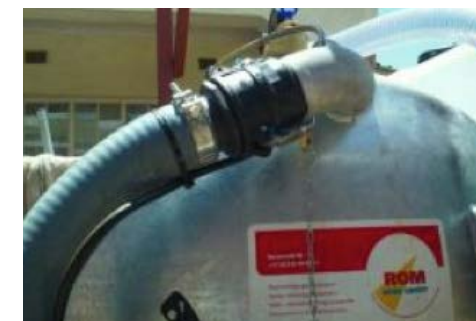
Figure 21: The plastic clamps were not durable and we experienced air leaks.

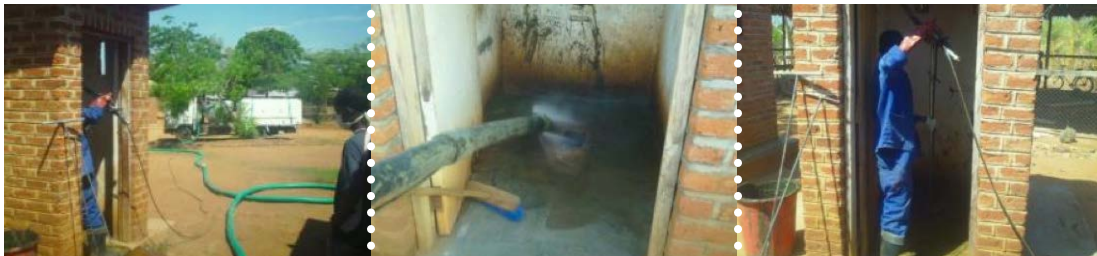
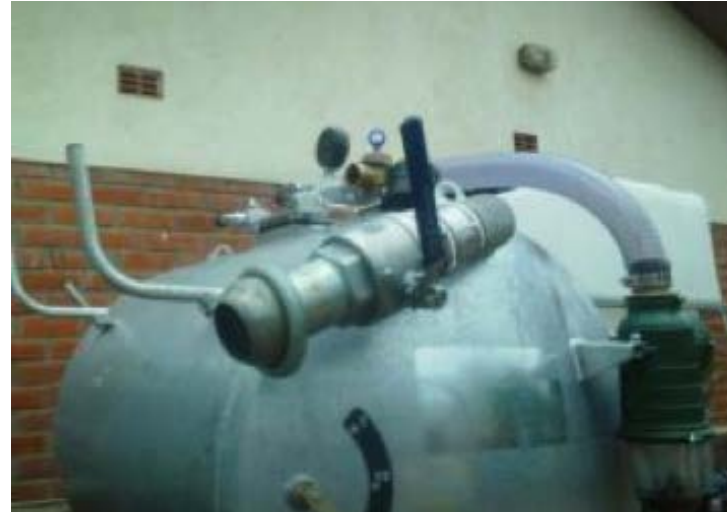
Figure 22: We changed to a metal and have observed they are more durable and have no air leaks. We changed the suction valve from plastic to metal. It is easier for the truck side operator to control the suction valve. The elbow somehow restricts the flow of the thick sludge.

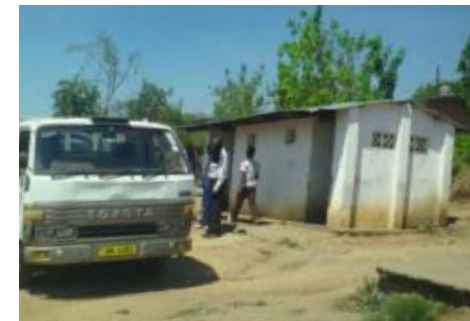
Figure 25: The original length of 3" suction pipe supplied is 15m, and is too short to access many toilets.

As outlined in our report, in order to access as many toilets as possible it is recommended that the suction pipes be of 3" diameter and 30m length. For ease of handling it is suggested they come in 2 lengths of 15m.

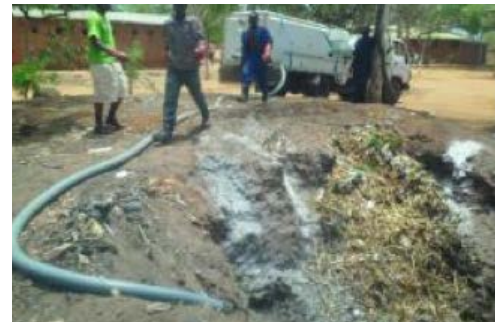
Figure 30: Increased length of discharge pipe – to make it safer and easier to discharge into a sewage disposal or pit.

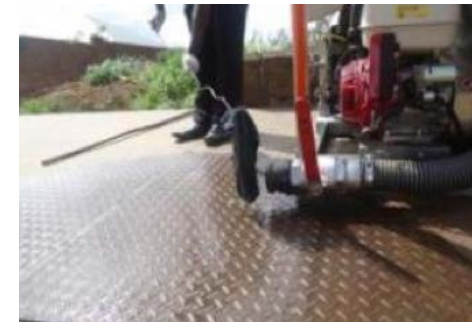
Figure 33: Some of the blockages were easily removed using a wire hook: in this case a pair of panties were removed from the discharge side.

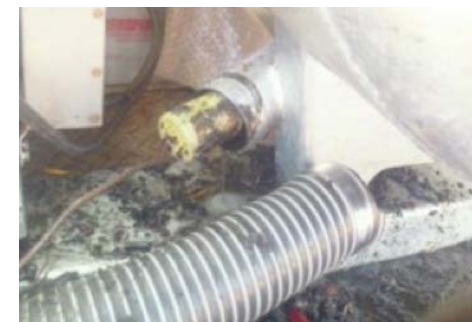
Figure 34: Items blocking discharge port include ARV bottles which escape fishing process – and we counted 4 bottles.

In November a serious blockage occurred where even pressurising was ineffective. We removed the inspection cover from the top and fished out several plastic medicine bottles, which were causing blockage with thick sludge such as stones, charcoal, etc. When the top inspection hatch was opened it was observed only one plastic bag, which was jamming the ball valve of the level indicator. This shows that while the fishing process is highly effective there are smaller items that cannot be fished out and will accumulate in the tank. In order to make the cleaning of blockages easier it was recommend to install an inspection hatch /man hole be fabricated on the end of the tank.

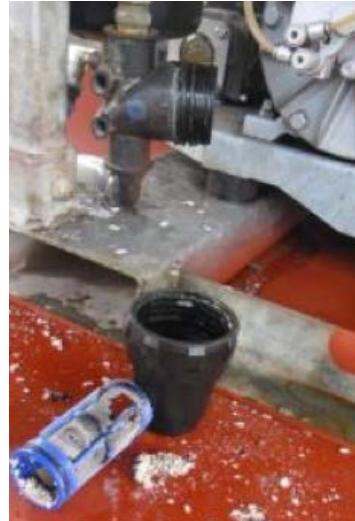
Figure 38: The filter body housing and the filter dismantled. The gauze of the filter has been perforated and there was a lot of sediment found in the filter housing.

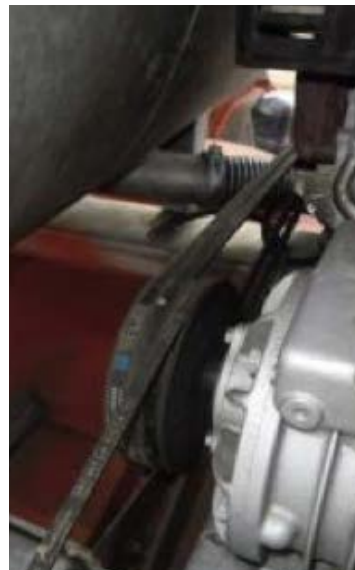
Figure 39: The drive belts broke and were replaced after 300 operations.

2. After 350 uses the **drive belts** for the vacuum pump and pressure pump broke. The 3 belts were readily available locally and cost €12 to replace. In an emergency situation, however they may form part of the spares kit.

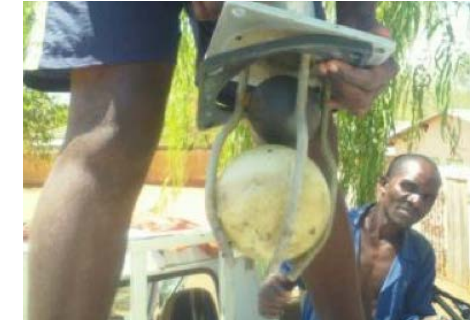
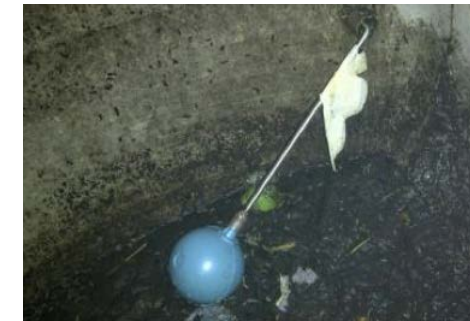
Figure 35: Dismantling top hatch.

Figure 36: Jammed ball valve.

See figures 35 and 36.

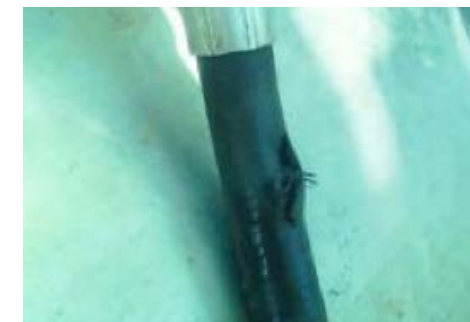
Figure 37: The pressure hose burst – it was seen that the pressure regulator was mistakenly set too high.

1. After more than 280 uses, the **pressure hose** burst. It was found that the pressure relief valve for the pressure pump was set at 120 bar, and it was reset to 50 – 60 bar. A new pressure hose was made using the same connections, just replacing the sleeves and hose. The job took less than 30 minutes by a specialist (Bearing and Machinery) and cost less than Euro100. In emergency situations, such a repair may not be readily available and it is suggested that the regulator is set and sealed to 60 bar to prevent a rupture in the first place and the pressure gauge is always set to be more visible to the operator. It is recommended that the pressure regulator be permanently set to 100 bar.

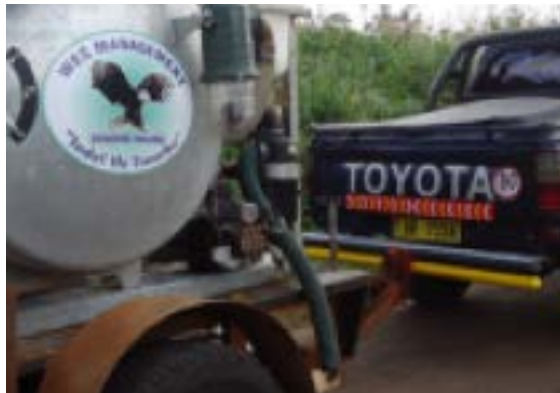
Figure 42: Trailer prototype using either 15" or 16" wheels for compatibility with towing vehicle. The trailer proved very stable on and off road. The 'bakkie' is also convenient for carrying 45m of 3" pipe (30m suction and 15 m delivery) plus equipment like safety clothes, buckets for rubbish, sprayer, fishing tools, etc.

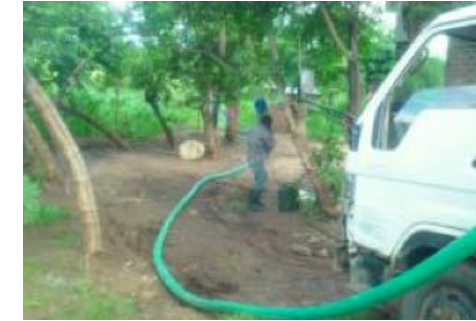
Figure 40: The Toilet is 30 m away – and inaccessible by the truck. Pressure hose to the right of the suction pipe.

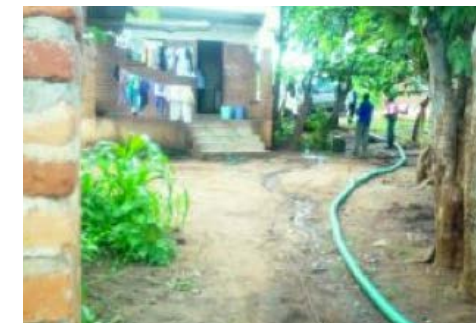
Figure 41: 30 m suction hose with 30 m high pressure hose (to the left) – distance was no problem either for pressurising nor for suction.

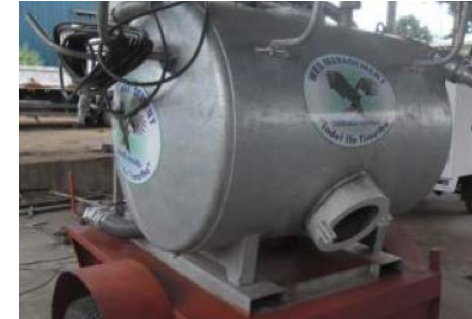
Figure 43: The inspection cover supplied by ROM was welded on by a local welding shop.

The inspection cover was fitted towards the end of March by Mike's Welding, at a cost of approximately €330. We will test this for airtightness and for ease of cleaning the ROM2 tank from blockages affecting the gauge and the discharge on site during operations as well as for general maintenance.

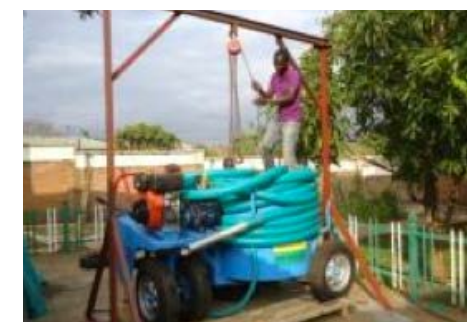
Figure 47: Lifting the Vacutug for assembly using lifting gear.

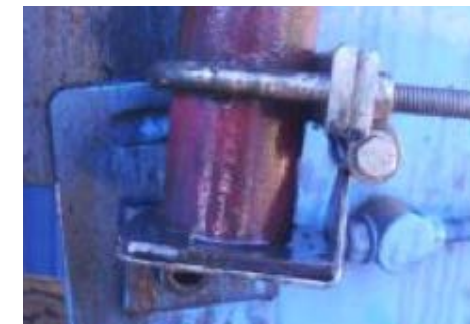
Figure 52: For the pressure chamber to be under vacuum the flap valve should be shut by lifting manually – it will remain sealed to maintain the vacuum.

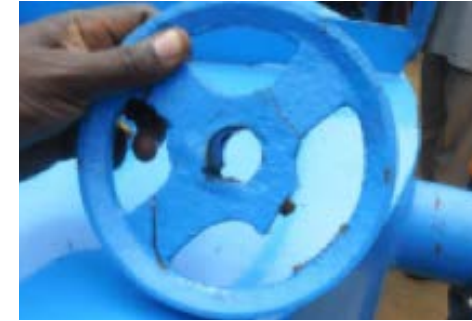
Figure 56: The original Vacutug pulley broke – and we failed a decent repair and could not find an off the shelf replacement.

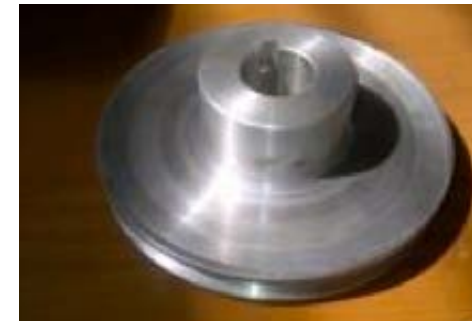
Figure 57: The newly made pulley made by a local workshop.

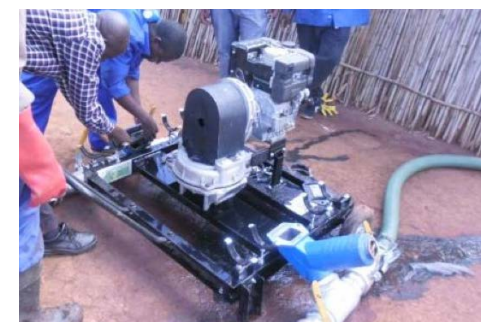
Figure 65: Dismantling, cleaning and reassembly of the 2 ports takes 30 minutes.

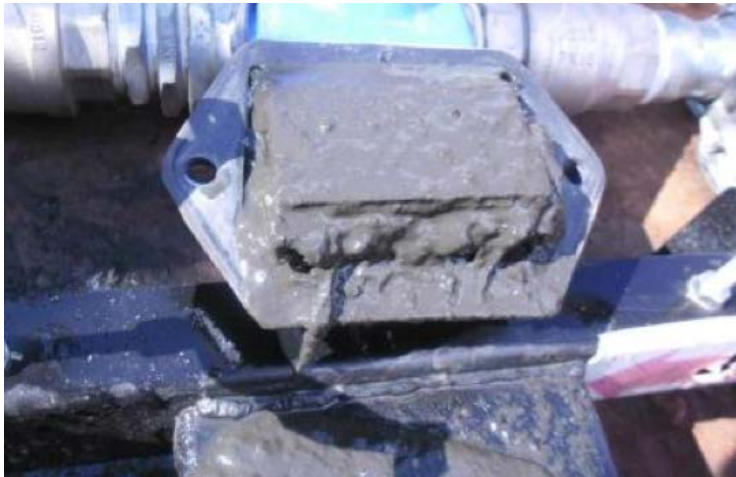
Note: in both pictures, the sludge is quite thick – so the pump has the capacity to pump; the problem is the rubbish in the sludge, which cannot be fished out.

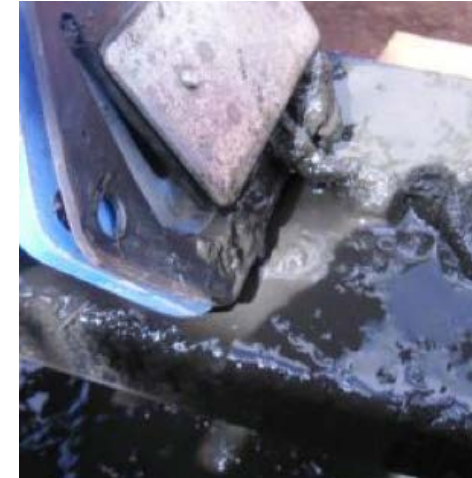
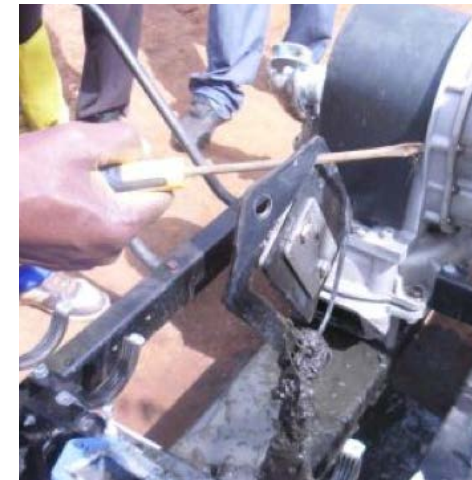
Figure 66: Suction port is not sealed due to a small piece of cloth.

Figure 67: Suction port is not sealed due to a small piece of cloth.

The supplier of the pump has agreed with the report's findings and has designed a macerator pump that is suitable for use with hard sludge with rubbish. The macerator pump has yet to be tested in field conditions.

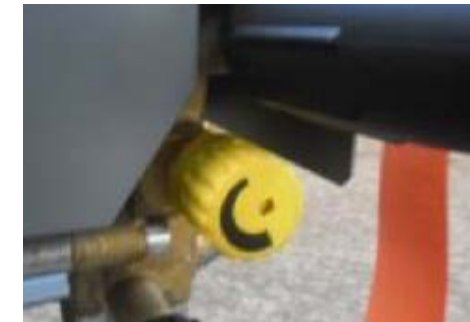
Figure 70: Details Karcher pressure washer. The pressure of the water jet is regulated by the knob.

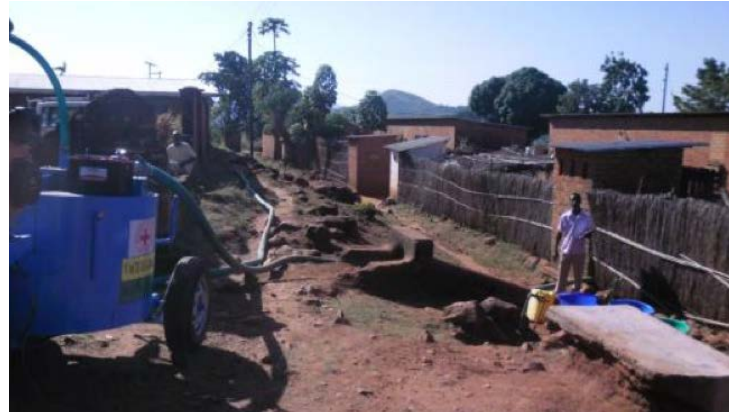
Figure 72: With fluidising the Vacutug was able to access and empty hard toilet sludge from a distance of 30m and an elevation of 2m. The Karcher fluidiser is next to the toilet (white building in the background). Otherwise the toilet would have been inaccessible.

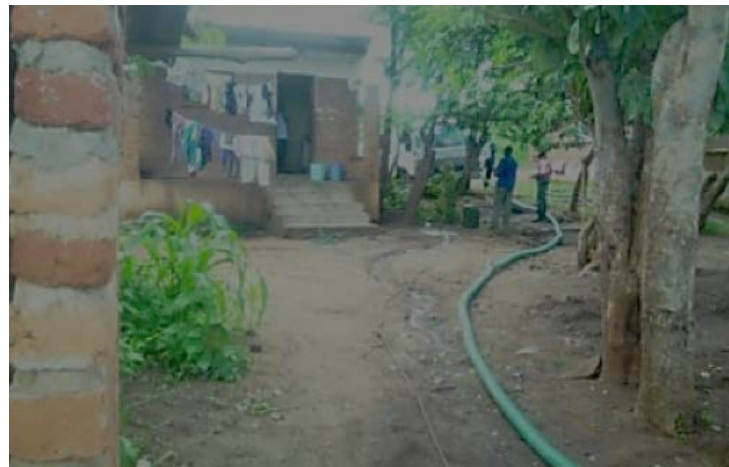
Figure 73: With the ROM2 a 30 m suction hose with 30 m high pressure hose (to the left) and performance was good.

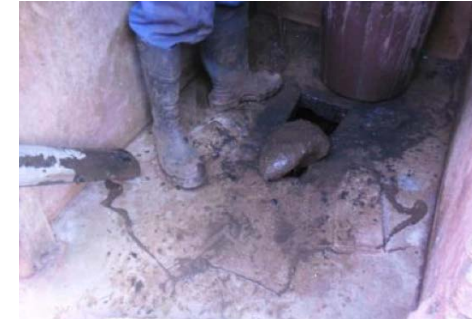
Figure 74: The sludge is often so thick and solid that rocks like this are suspended and are loosened during the fluidising process.

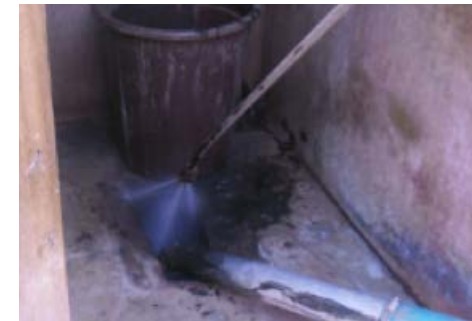
Figure 75: Fluidising is an essential part of pit emptying – including fishing out of rubbish from the now softer sludge and the pumping out the sludge.

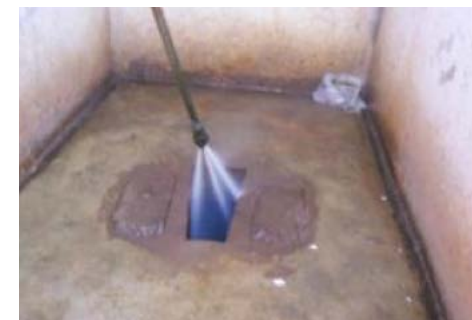
Figure 76: The fluidiser - with the pointed nozzle is essential for the safe cleaning process.

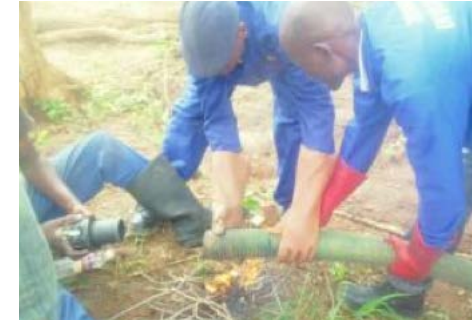
Figure 77: Heating the hose to fit the Camlock.

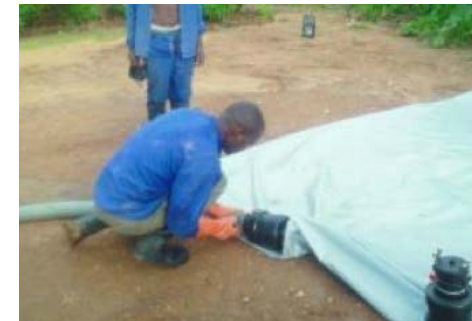
Figure 78: Fitting Camlock.

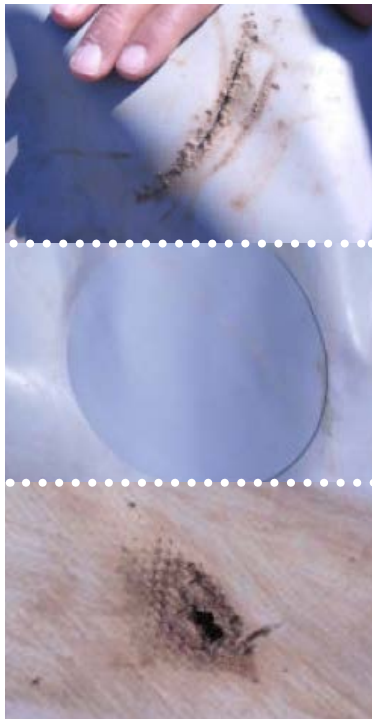
Figure 81: Rip outer layer.

We found a couple of tears and punctures on the bladder, at the bottom side.

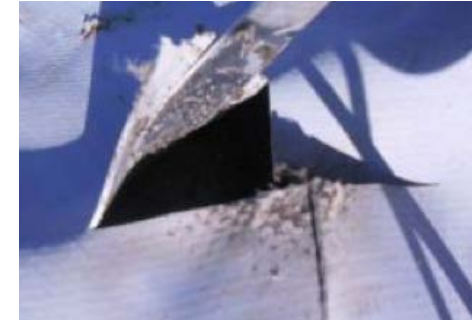
Figure 84: We opened the outer layer puncture in order to repair the inner layer, but found that sludge had leaked from the bladder in between the layers. This meant we could not access the inner layer for repairs. We just repaired the outer layer.

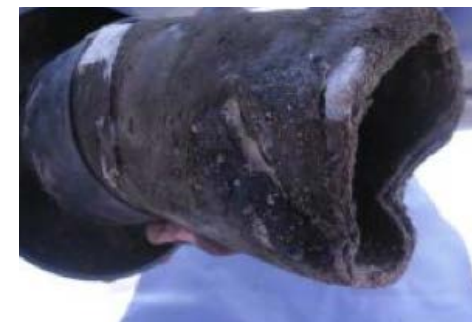
Figure 85: The active carbon cartridge has completely deteriorated.....but the plastic cover will only fit the cartridge.

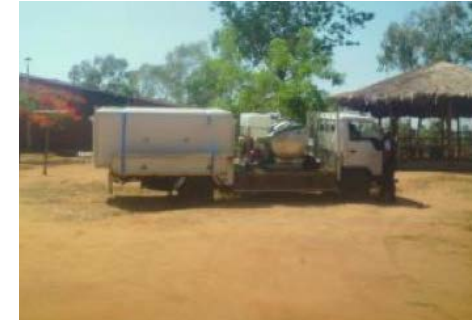
Figure 86: The tank was mounted on a 3 ton lorry, together with the ROM2. However it is advisable to mount the tank and possibly desludging pump in a 7 ton lorry.

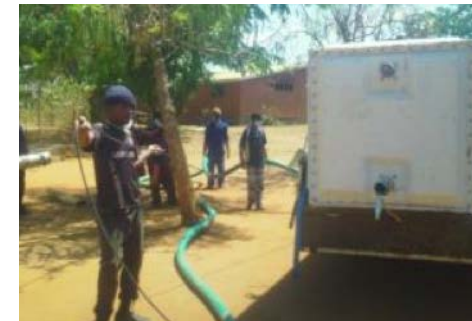
Figure 87: Due to the position of the discharge port, the tank cannot be wcompletely emptied of about 0.5 m³ sludge.
